**Flood Control Project Maintenance
Levee Inspections**
LMA District Cover Sheet
Spring 2020 Levee Inspection Results

Sacramento Maintenance Yard Willow Slough Bypass

Spring 2020 Levee Inspection Results

Waterway			Bank	Unit Miles
Unit No. 01 Willow Slough Bypass or North Levee			Left	5.05
	Spring (March - May)	Summer (June - August)	(September - November) Fall	Winter (December - February)
Unit Maintenance Rating (Fall Only)				
Date of Inspection	4/7/2020 - 4/7/2020			
DWR Inspector	Zach Jojola			
Accompanied By

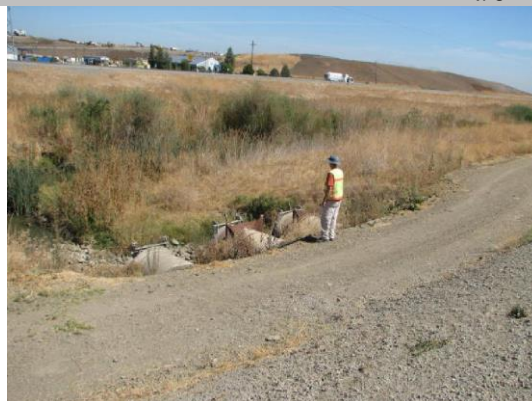
Photo 2 of 3 : UCIP_SP_2020_45294_22788.jpg

LM Start	3.61	Rating **	A/W	Issue No.	50 (cont)
LM End	3.61	Issue Type +	Ma	Location *	
Category	Supplemental		GPS Latitude/Longitude		
			Start	End	
Item	DWR UCIP LMA Responsibility		38.589570 °	38.589570 °	
			-121.693090 °	-121.693090 °	
DWR ID	541

Waterside overview-

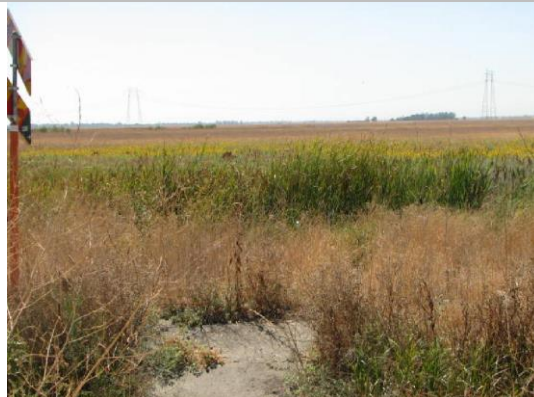
Photo 3 of 3 : UCIP_SP_2020_45307_22870.jpg

LM Start	6.07	Rating **	A/W	Issue No.	59 (cont)
LM End	6.07	Issue Type +	Ma	Location *	
Category	Supplemental		GPS Latitude/Longitude		
			Start	End	
Item	DWR UCIP LMA Responsibility		38.589040 °	38.589040 °	
			-121.647870 °	-121.647870 °	
DWR ID	553

Landside view- overview
